Lake George Association

NEWS RELEASE

LGA Completes Lake Saving Project at English Brook

Lake George, NY – November 7, 2011 – The Lake George Association has completed the construction of a new sediment basin at the mouth of English Brook.

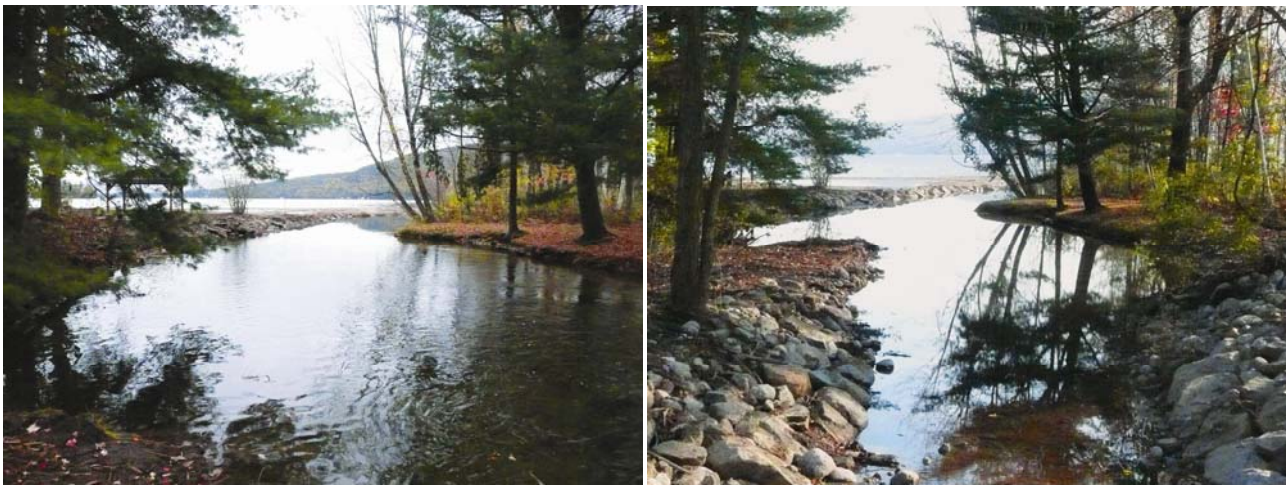
Photo Caption: The LGA has constructed a new sediment pond at English Brook. The pond is designed to capture hundreds of tons of sediment before it enters Lake George.

Construction of the basin was completed during the last week of October. The 150-foot long sediment basin was designed by the Warren County Soil and Water Conservation District (WCSWCD) with financial assistance from the LGA. The basin will slow down the flow of water and allow sediment to fall out prior to entering the Lake. Grass pavers were also installed to enable future access to the site so that it can be maintained. The basin will be cleaned out every one to two years, when it reaches about 50-75% capacity. Each time it is cleaned out, roughly 300-400 cubic yards of material will be removed.

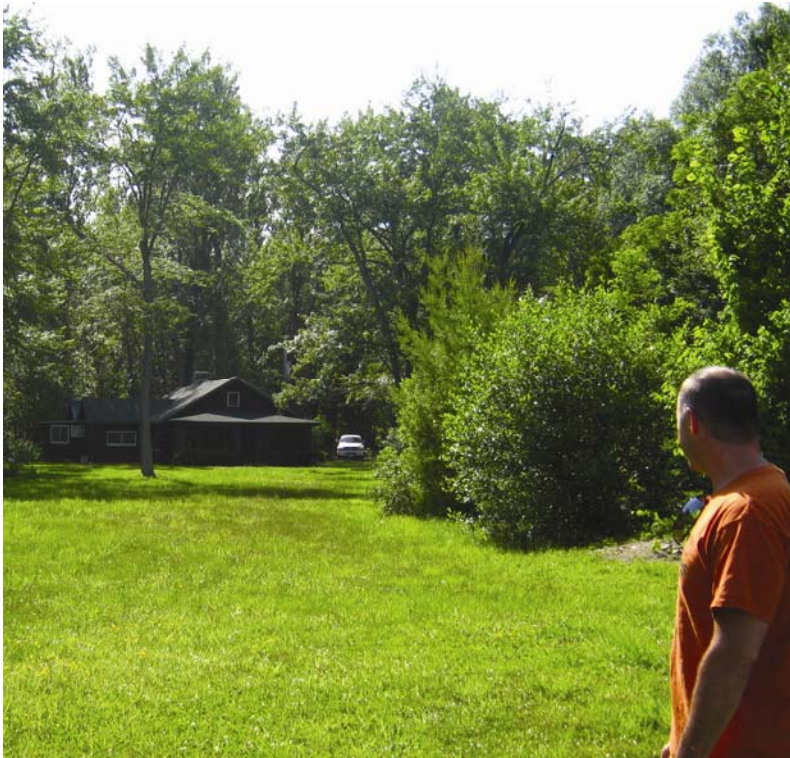
Photo caption: Dave Wick, executive director of the Warren County Soil and Water Conservation District, stands at the current Lake George shoreline near the mouth of English Brook, and looks back at a cottage that was located at the water's edge some 50 years ago. Construction of the Northway, as well as other development projects, increased the amount of sediment carried downstream and caused the location of the shoreline to change significantly.

Since the construction of the Northway, the shoreline near the mouth of English Brook has moved significantly. A cottage that was once right on the lake now sits several hundred yards back. The DEC lists the brook as sediment impaired, and its delta is one of the largest on Lake George. According to National Urban Runoff Program reports conducted during the 1980s, English Brook has high levels of total phosphorus, chlorides, total suspended sediments, lead and nitrate-nitrogen.
